Clean Water

Pipe Inspection Tecnology

Drain Line Inclination Checker Crawler

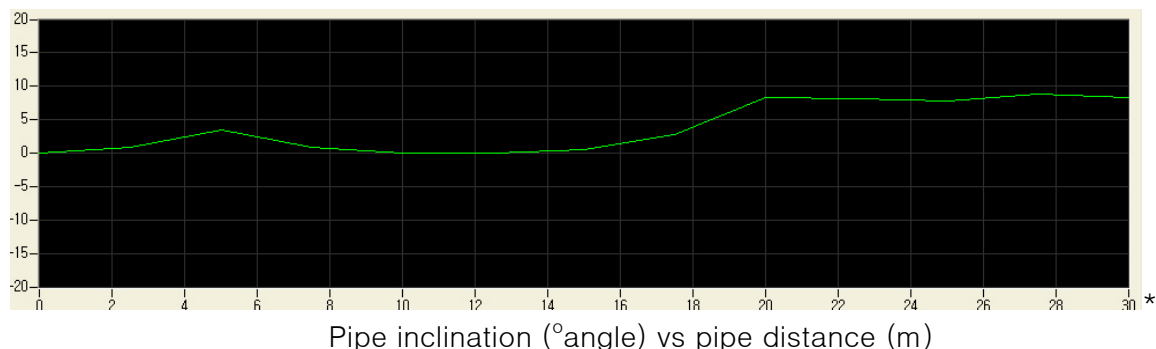
Inclination graph :

Interpretation : Negative slope of the test pipe line was found between 0~4.5m. The same negative slope was found from 13~20m These sections of pipe may affect the sewer flow and trap sewer waste when the pipe is running partially dry.

* average inclination of each section

0 ~ 1 M : 0.05
 11 ~ 20 M : 0.04
 21 ~ 30 M : 0.04
 31 ~ 40 M : 0.03

* total average : 0.04.

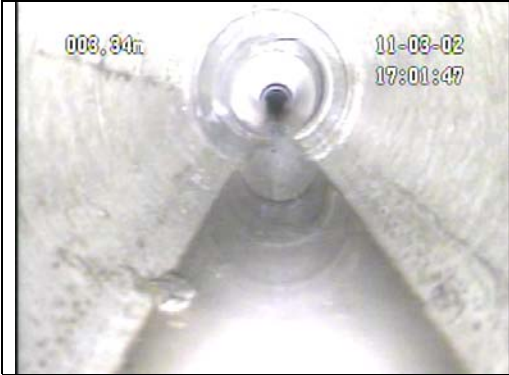
<p>003.34m 11-08-02 17:01:47</p>

<p>004.64m 11-08-02 17:01:55</p>
<p>1. At 3.34M (water remains at the bottom of the pipe – evidence of reversed inclination)</p>	<p>2. At 4.64M (Positive flow and the pipe is dry)</p>

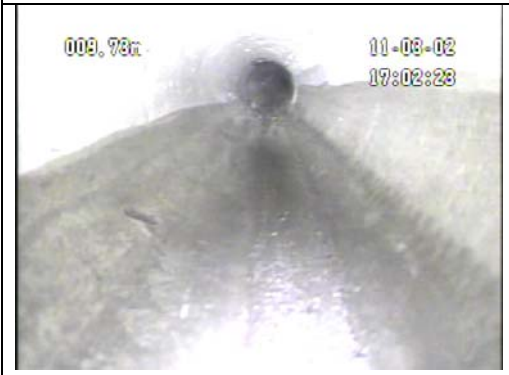
<p>008.78m 11-08-02 17:02:28</p>

<p>014.44m 11-08-02 17:02:51</p>
<p>3. At 8.78M (inclination is OK)</p>	<p>4. At 14.44M (problem in inclination, some soil remained)</p>

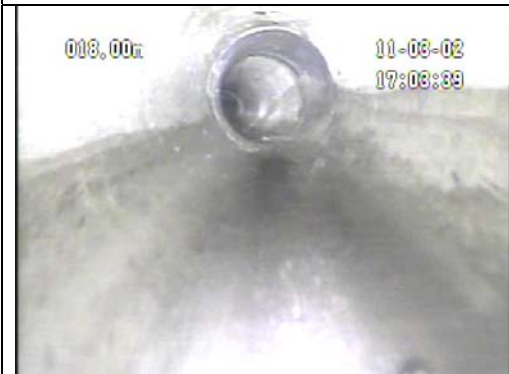
<p>018.00m 11-08-02 17:03:33</p>

<p>025.44m 11-08-02 17:04:10</p>
<p>5. At 18M (wrong inclination but CCTV looked like Ok. That is why you need inclinometer to review the problem area)</p>	<p>6. At 25.44M (inclination is OK)</p>
